Bureau of Reclamation

# OPERATION AND MAINTENANCE EQUIPMENT AND PROCEDURES

RELEASE NO. 15

January, February and March 1956

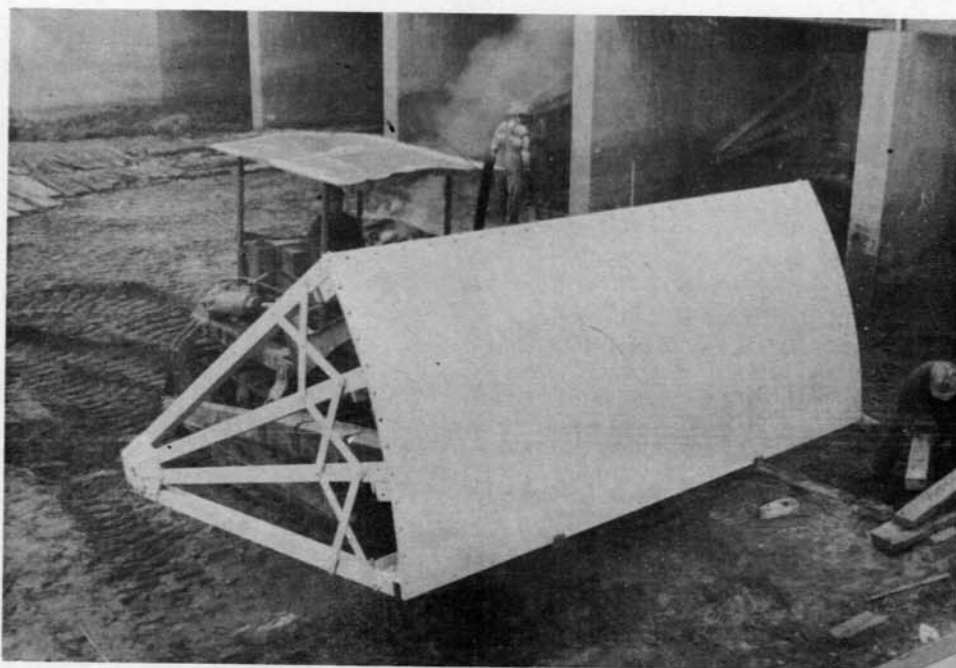
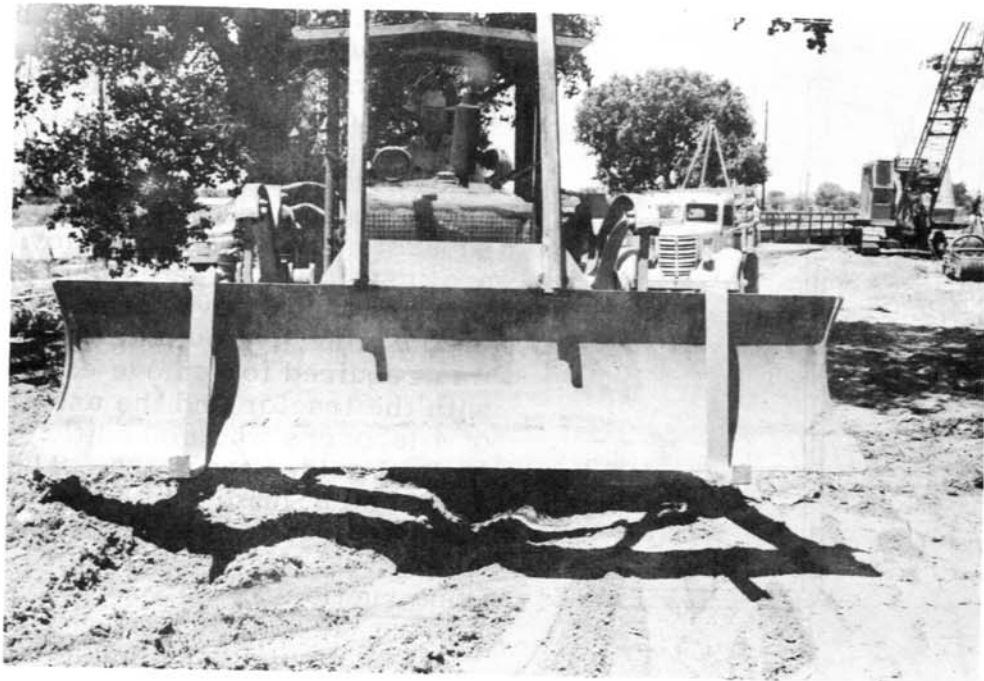
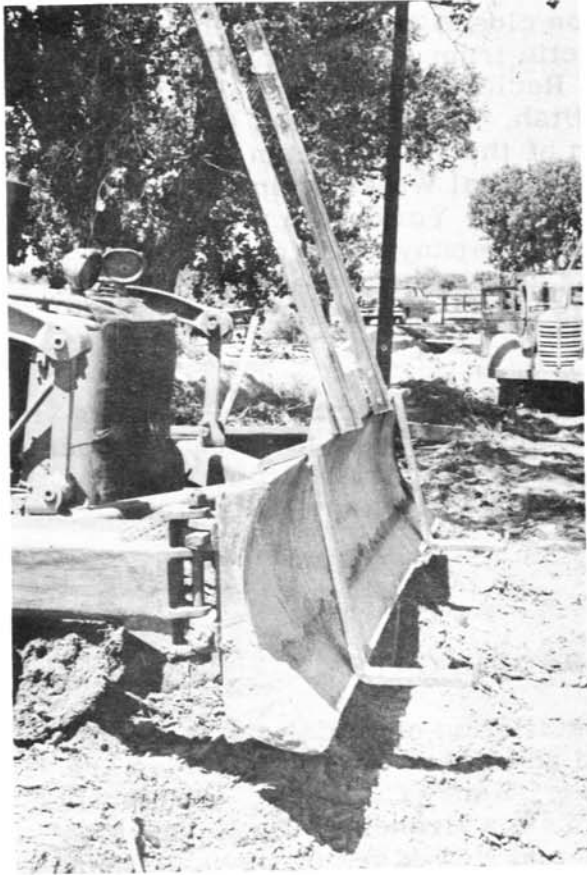
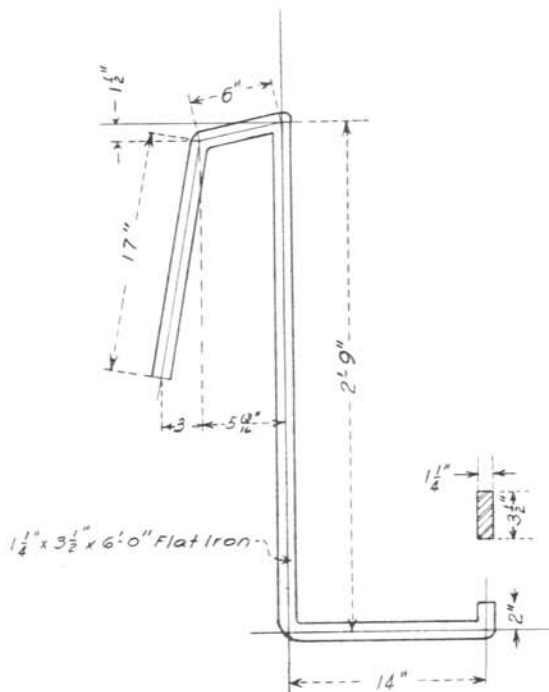
To facilitate removal and installation of radial gates which are too large to handle easily by hand and where hoisting devices are not available or are inconvenient to use, Henry C. Lange, Maintenance Supervisor of Irrigation Operations, Ysleta Branch of the Bureau constructed Rio Grande Project in Texas and New Mexico, devised a simple attachment for use on a bulldozer blade. The device and its use are shown on the cover and below.

The method shown was used to remove and replace five 6- by 16-foot radial gates at the River-side Canal Headworks. Each gate had two arms attached with a radius of 10 feet each. The gates fit in back of a concrete opening and had to be removed and replaced through the back side of the structure. A timber bridge and gate operating platform directly over the gate opening prohibited the use of a dragline without first removing these structures.

The concrete apron below the gates was covered with about 2 feet of sand from the canal and river, to allow the tractor to move without damage to the concrete. By inserting the hook arms on the dozer blade under a radial gate, it was raised or lowered and moved backward or forward as required.

Prior to devising the method of handling the gates with the bulldozer, it was planned to put skid timbers under the gates and slide them out by means of snatch blocks in line with each gate using a chain block winch for vertical leverage. This winch would have had to be attached to a beam beside the bridge stringers and would have had to be placed in at least three separate positions for removing and installing the gates; an operation that would have taken considerable time. About one-half hour was required to remove each gate with the tractor and the assistance of 4 laborers who placed the blocking and guided the gates. The same time, labor and equipment was required to install the gates.

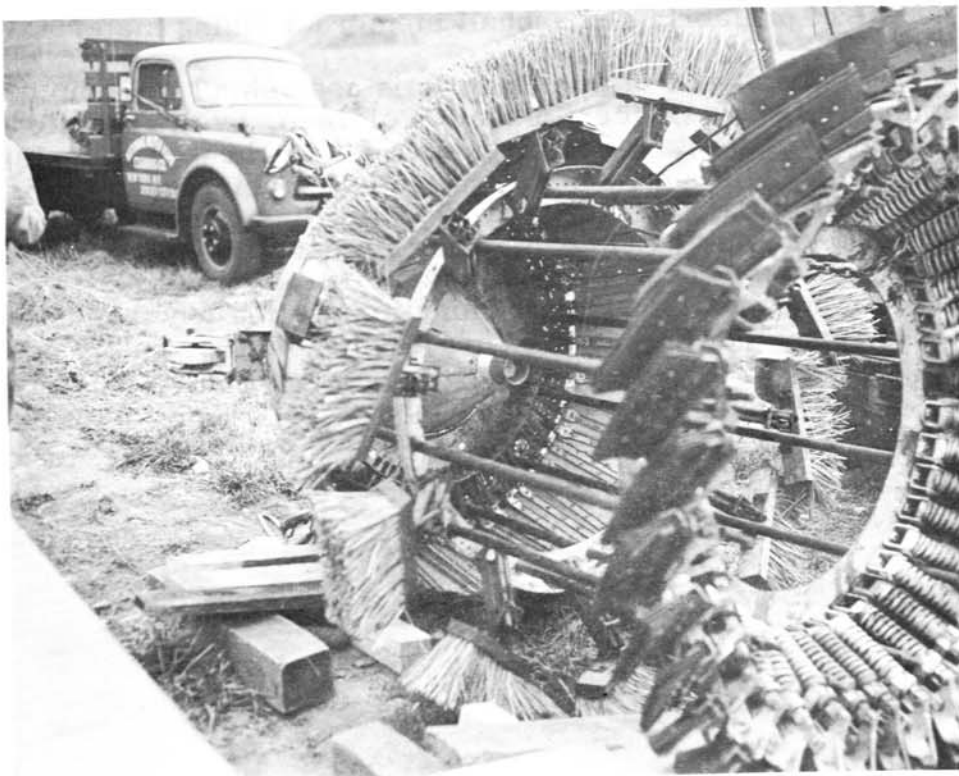
A deposition and accumulation of slime, brownish in color and largely manganese, on the wetted perimeter of the conduit pipe and tunnels of the Salt Lake Aqueduct is repulsive in appearance and affects to some extent the potability of the water conveyed. In 1954, the Metropolitan Water District of Salt Lake City, Utah, operators of the aqueduct, engaged the services of the National Water Main Cleaning Company of New York to clean portions of the aqueduct. For the operation, the New York firm fabricated the self propelled cleaning device shown below. It was forced through the aqueduct by a small head of water, brushing the perimeter of the conduit and largely removing all the slime. The rig was used a second time in 1955.

The Salt Lake Aqueduct was constructed by the Bureau of Reclamation as a part of the Provo River Project to convey water from Deer Creek Reservoir to a point near Salt Lake City, Utah. Upon completion of construction, the system was turned over to the Metropolitan Water District for operation. The aqueduct consists of a covered conduit approximately 40 miles in length with a capacity of about 150 cfs. In addition to two concrete lined tunnels, the system is composed of 69-inch diameter concrete pipe, except where 70-inch diameter steel pipe is used at sections having high head.

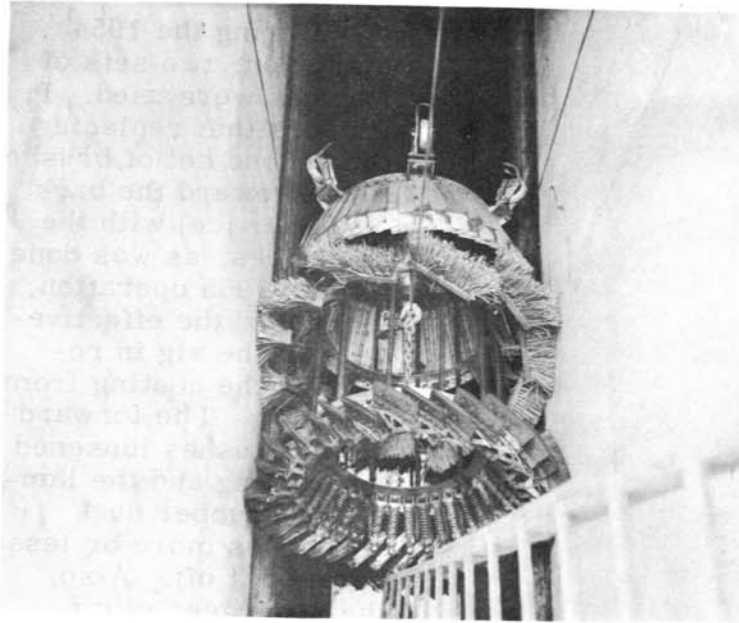
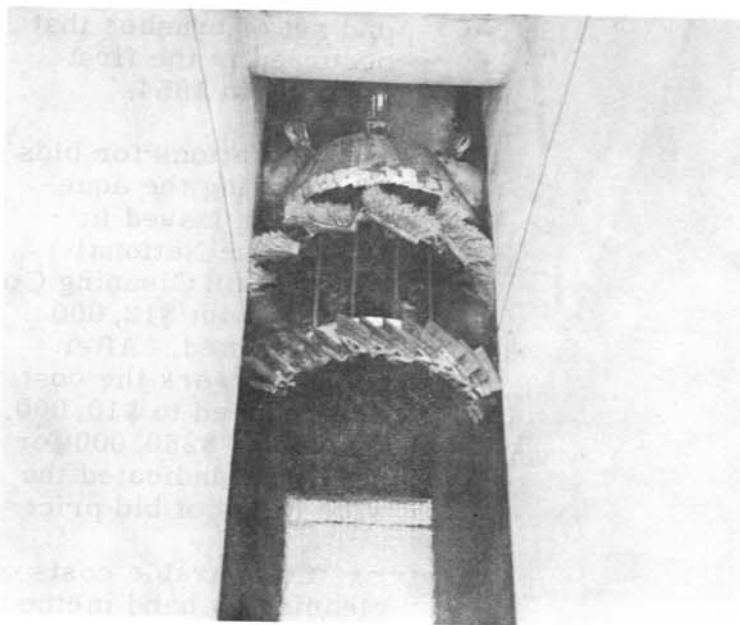
1,000 feet downstream from the intake. At this point the cleaning rig was lowered into the aqueduct pipe. Lifting and lowering of the rig, as shown at left, was accomplished with an A-frame hoist mounted on a 4-wheel drive truck, belonging to the Metropolitan Water District. After the rig was in place, as shown in the lower photograph, water was turned into the conduit. When the flow of water reached about 33 or 34 second-feet, in the 150-second feet capacity pipe, sufficient head was built up behind the rig to start it down the aqueduct. After the rig had started, the flow was increased and maintained at about 70 to 80 cfs.

About 25 to 30 hours were required for the cleaning device to move from the vent to the transition of the Alpine-Drapper tunnel, a distance of about 21 miles, where it was removed and returned to the vent for a second run.

Location of the device as it moved through the aqueduct was detected by use of an oscillator. Twice through the aqueduct and the cleaning was accomplished.

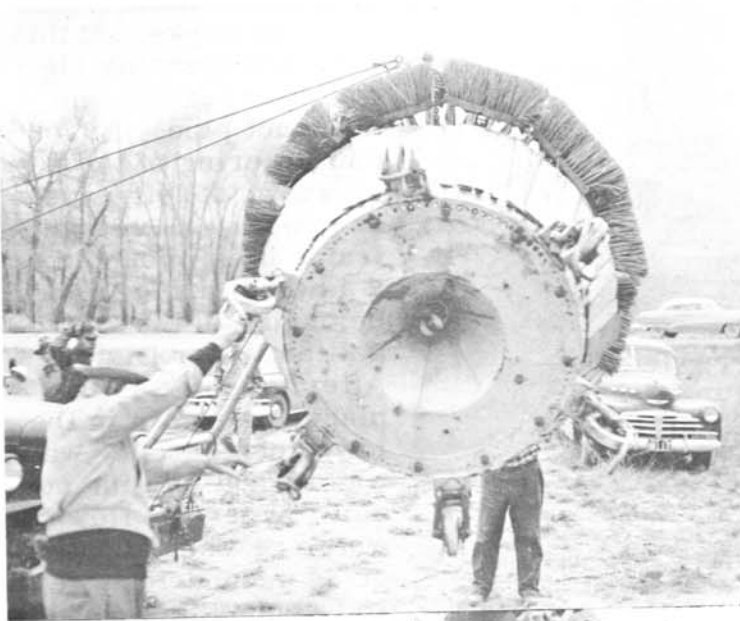
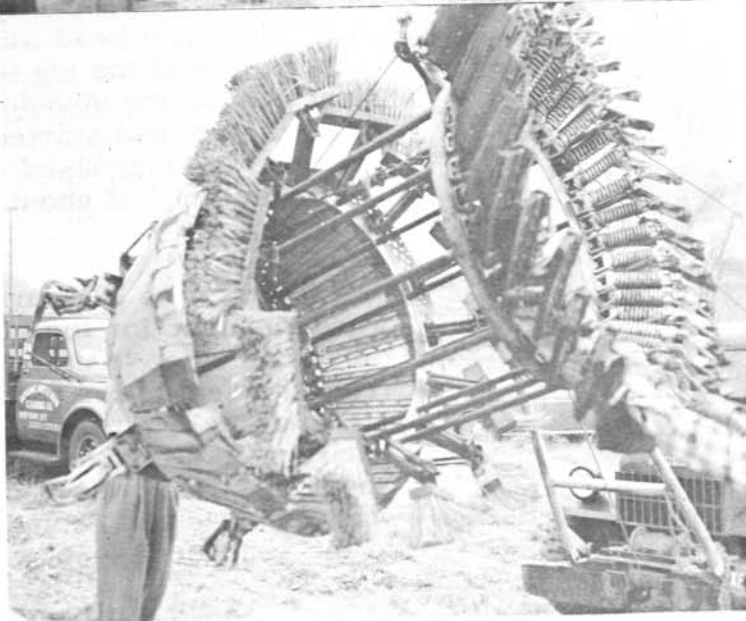
More detail of the cleaning rig can be seen in the views shown on the following page. In the upper view, the front end of the rig is shown. In the lower view, the side of the rig. The springs which control the brushes and the laminated rubber duck squeegees permit the device to move through conduits which vary as much as 4 inches in diameter.

During the 1954 operation, two sets of brushes were used. It appears that replacing the second set of brushes (those toward the back of the device) with the squeegees, as was done for the 1955 operation, increased the effectiveness of the rig in removing the coating from the pipe. The forward set of brushes loosened the coating and the laminated, rubber duck squeegees more or less scraped it off. Also, the squeegees eliminated the wear on a second set of brushes that occurred in the first cleaning in 1954.

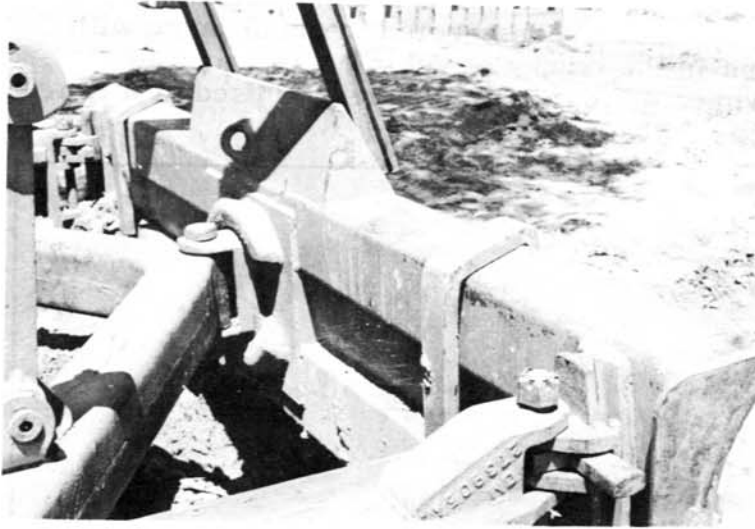
The device used consisted of two S-shaped hooks, with the

reverse hook hung over the top of the bulldozer blade for the gate to rest on. Also two guides or supports were attached to the top of the blade for the gates to rest against while on the hooks.

Material used in the fabrication of the hooks, as shown on the drawing, consisted of two pieces of  $1\frac{1}{4}$ - by  $3\frac{1}{2}$ -inch flatiron, 6 feet long. The hooks were bent to shape and were

hung over the blade on each side. Two pieces of  $1\frac{3}{4}$ - by 4-inch channel iron or lightweight steel rail, each 4 feet long were spot-welded 3 feet apart near the top of the bulldozer blade, as shown in the photograph above.

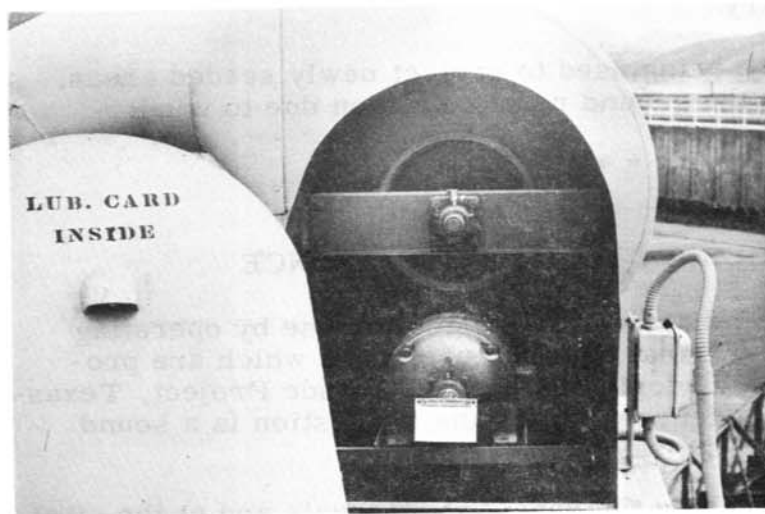
To insure the use of the proper type and grade of lubricant on the varied and complex equipment at Imperial Dam and Desilting works, lubrication data cards similar to that shown at left and on the following page are attached to each piece of equipment as a guide to maintenance personnel.

At left, the lubrication card is attached to the electric motor of a blower for venti-

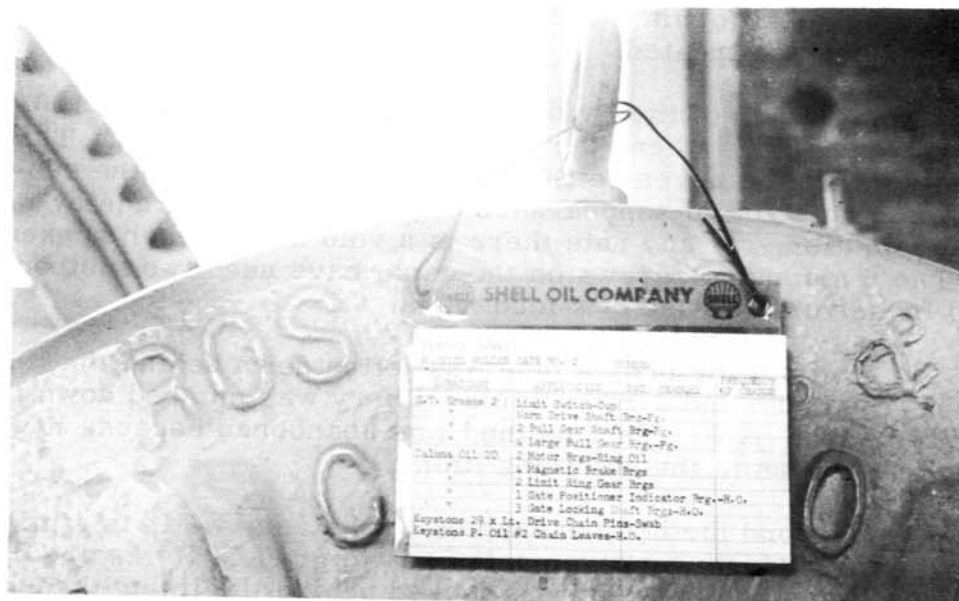
lating a sludge pipe gallery. In the photograph below, a card is attached to the hoist mechanism of the intake roller gates. The one card includes the lubrication data for several individual mechanical features.

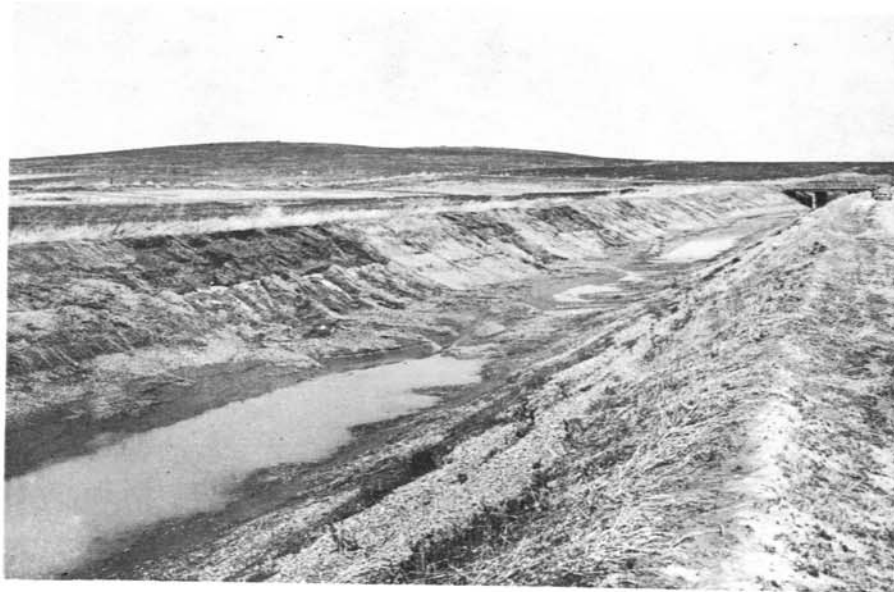
On May 16, 1955 and again on May 25 and 26, heavy rains occurred along the Ft. Laramie Canal. Water poured over the upper embankment in a number of places, removing the gravel blanket and earth covering and tearing out asphaltic membrane lining. Typical is the view above, with more detail of a more severely damaged reach shown on the following page.

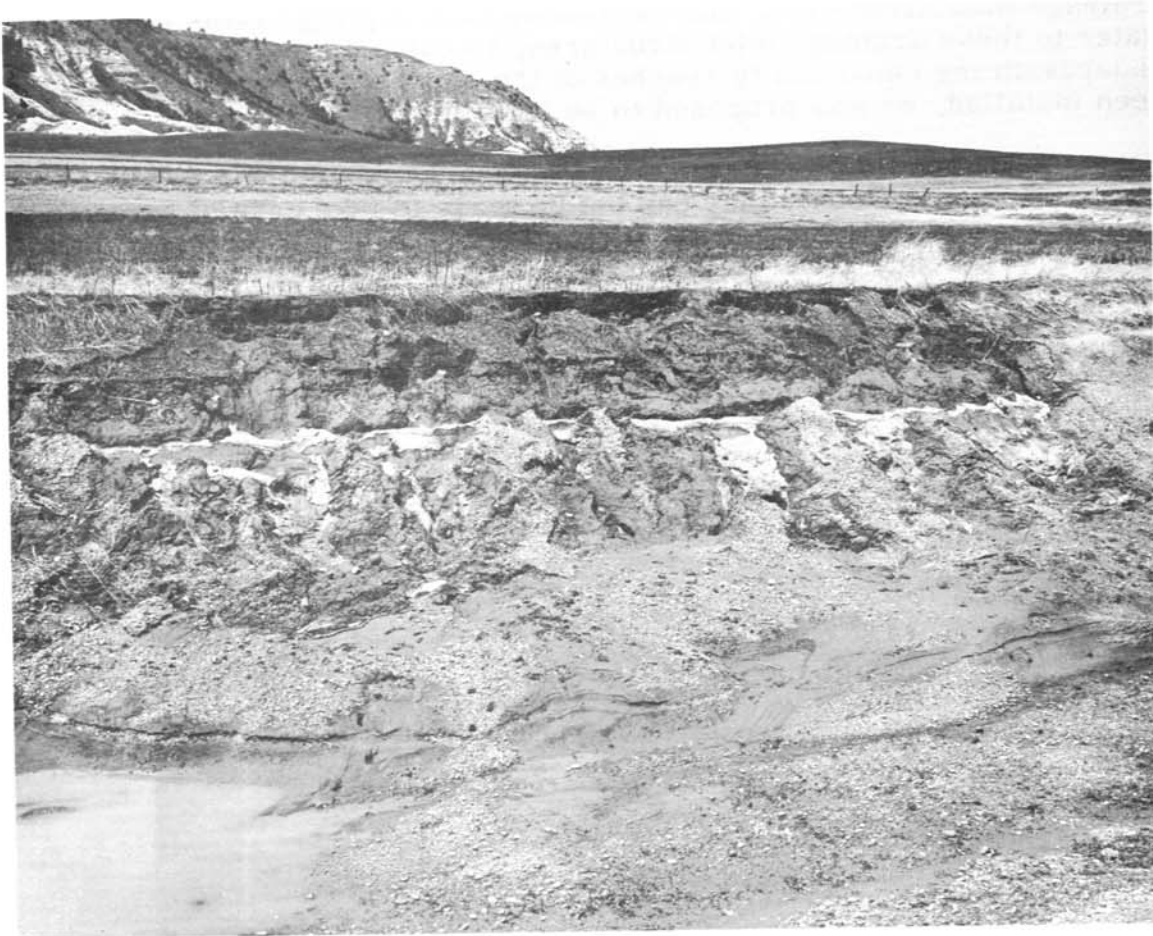
The damage to the asphaltic membrane and its protective covering was not total in many places where the water had run over the embank-

ment. In some places only a small amount of cover had been washed away and this only above normal water surface in the canal. In other cases more or less cover had been washed off the asphaltic lining without affecting it, but there were reaches where all cover and asphaltic lining had been removed from the upper embankment leaving many ragged edges of torn asphaltic lining. In no case was any appreciable damage done to the lining in the bottom or on the lower embankment of the canal. All together, there was approximately 600 feet of canal affected by the flooding.

Since it was so late in the season, it was necessary that repairs to the damaged lining be made as quickly as possible. It was unlikely that the small amount of catalytically blown asphalt needed

for the repair work could be obtained on short notice from the refineries at Cody or Casper, Wyoming. Luckily, a local lumber company had, a short time previously, stocked a carload of Johns-Manville asbestos Pre-Fabricated Canal Liner. It was decided to use this material because of its immediate availability and ease of handling, and because neither expensive equipment nor skilled labor is required in its installation.

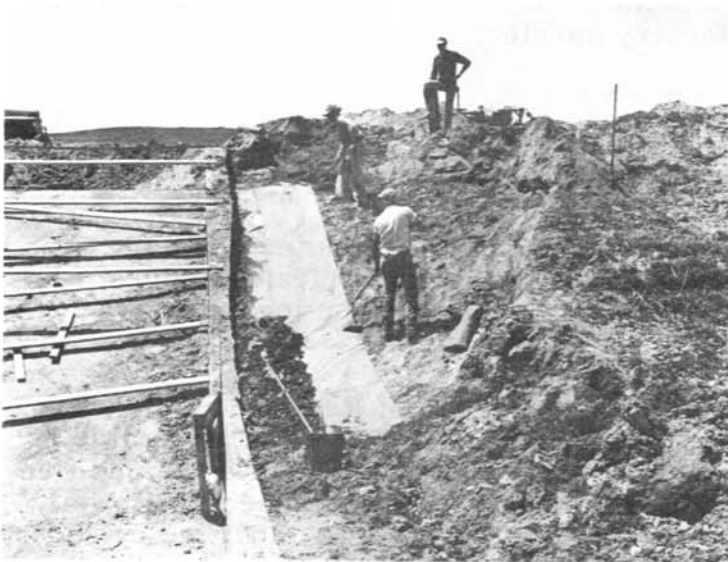
The prefabricated lining material also was convenient to use adjacent to structures in patching the original membrane lining, as shown at left. The prefabricated material lays very nicely on a properly prepared surface that is close to being a true plane. If the subgrade surface is not reasonably smooth, there will be "fish-mouths" in too many places. These are sources of leakage, and should be avoided.

The Johns-Manville Asbestos Pre-Fab Canal Liner was placed in both longitudinal and transverse position, whichever method seemed to best fit the condition of the area being repaired. Generally, it was placed in a transverse position. Laps to a minimum of 3 inches were made except where pieces were greater in length than 18 feet. Then the lap was increased to a minimum of 6 inches. The lap on the previously installed hot-applied asphaltic membrane was kept to a minimum of 6 inches. Pre-Fab Canal Liner Lap Cement was used. This cement apparently does a very good job of sealing the joints.

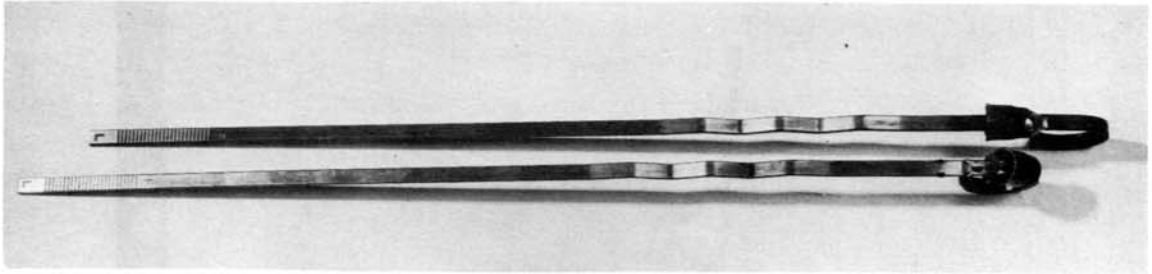
the vehicle is climbing. As delivered, the dip-stick depth-stop is crimped on the rod. With use, the stop is frequently jammed past the normal position, allowing the rod to go about an inch deeper into the oil reservoir, giving a content reading of approximately 1 quart over the actual content.

The photograph below shows the problem by comparison. It was corrected by simply immobilizing the depth-stop and cap in its proper position.

The Palisades Project Office, Bureau of Reclamation, Palisades, Idaho, is of the opinion that the suggestion is of considerable value where this particular vehicle is used, as the original, unmodified equipment was a constant source of difficulty. Mr. Horace R. Howell, Mechanic Foreman suggested that the oil dip-stick be modified by spot-welding or brazing the depth-stop and cap to the rod in the proper position so it could not be accidentally moved.

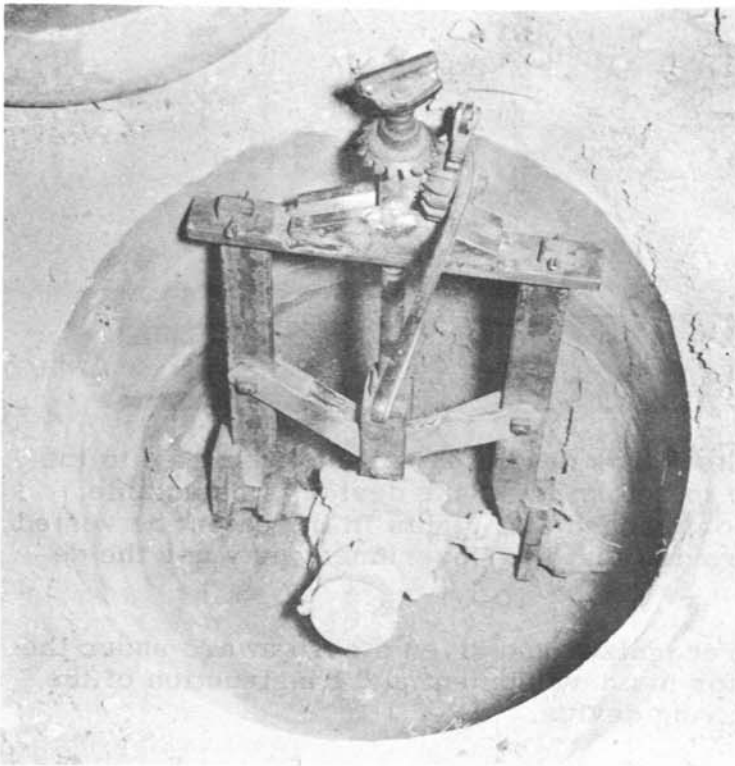
A mechanical device that saves time and facilitates the installation and removal of water meters was developed and constructed by Mr. Vernon G. Stockall of the Bureau's Boulder City Municipal Office, Boulder City, Nevada. Details of the device are shown in the photographs and drawing on the following pages.

The device forces the connecting pipes from both ends of the meter, after the couplings have been loosened. The meter can then be lifted out or replaced with a minimum

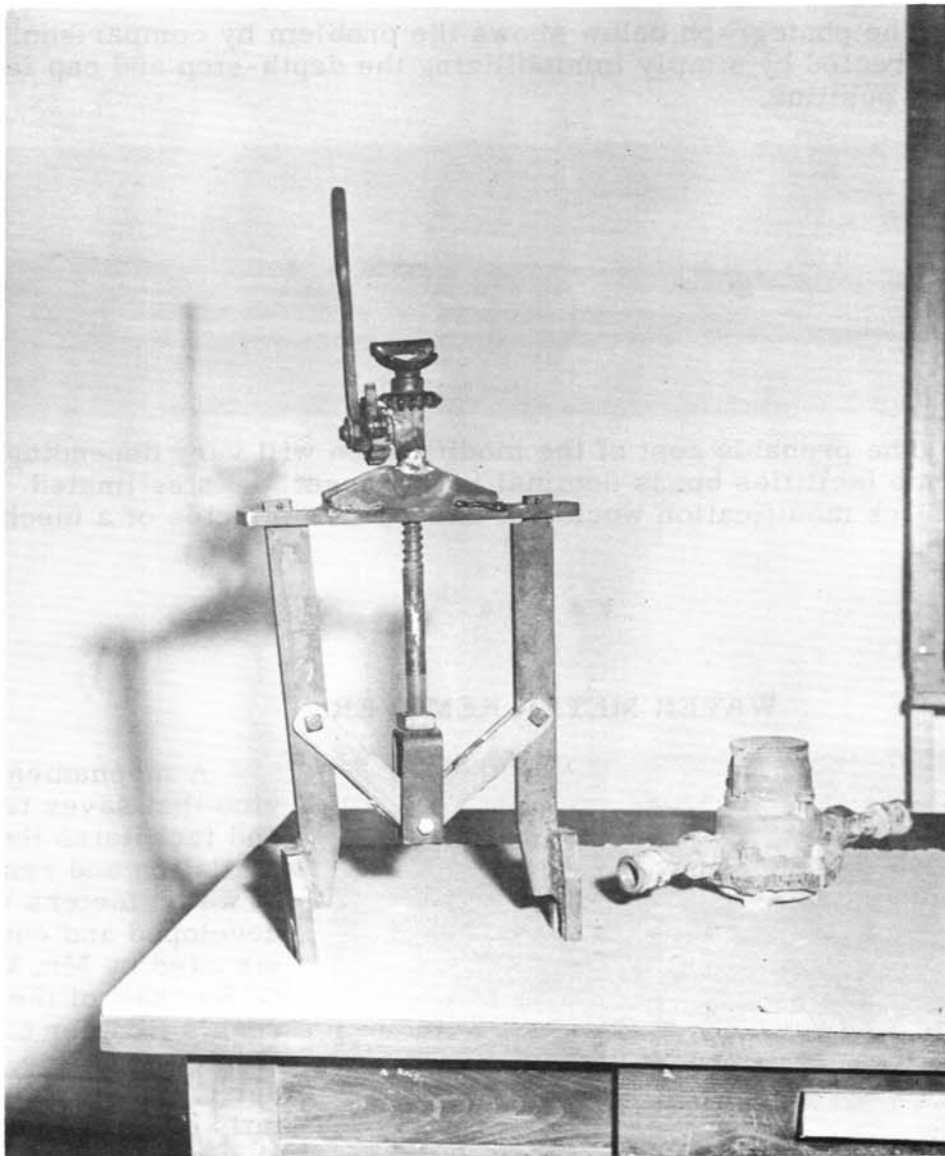
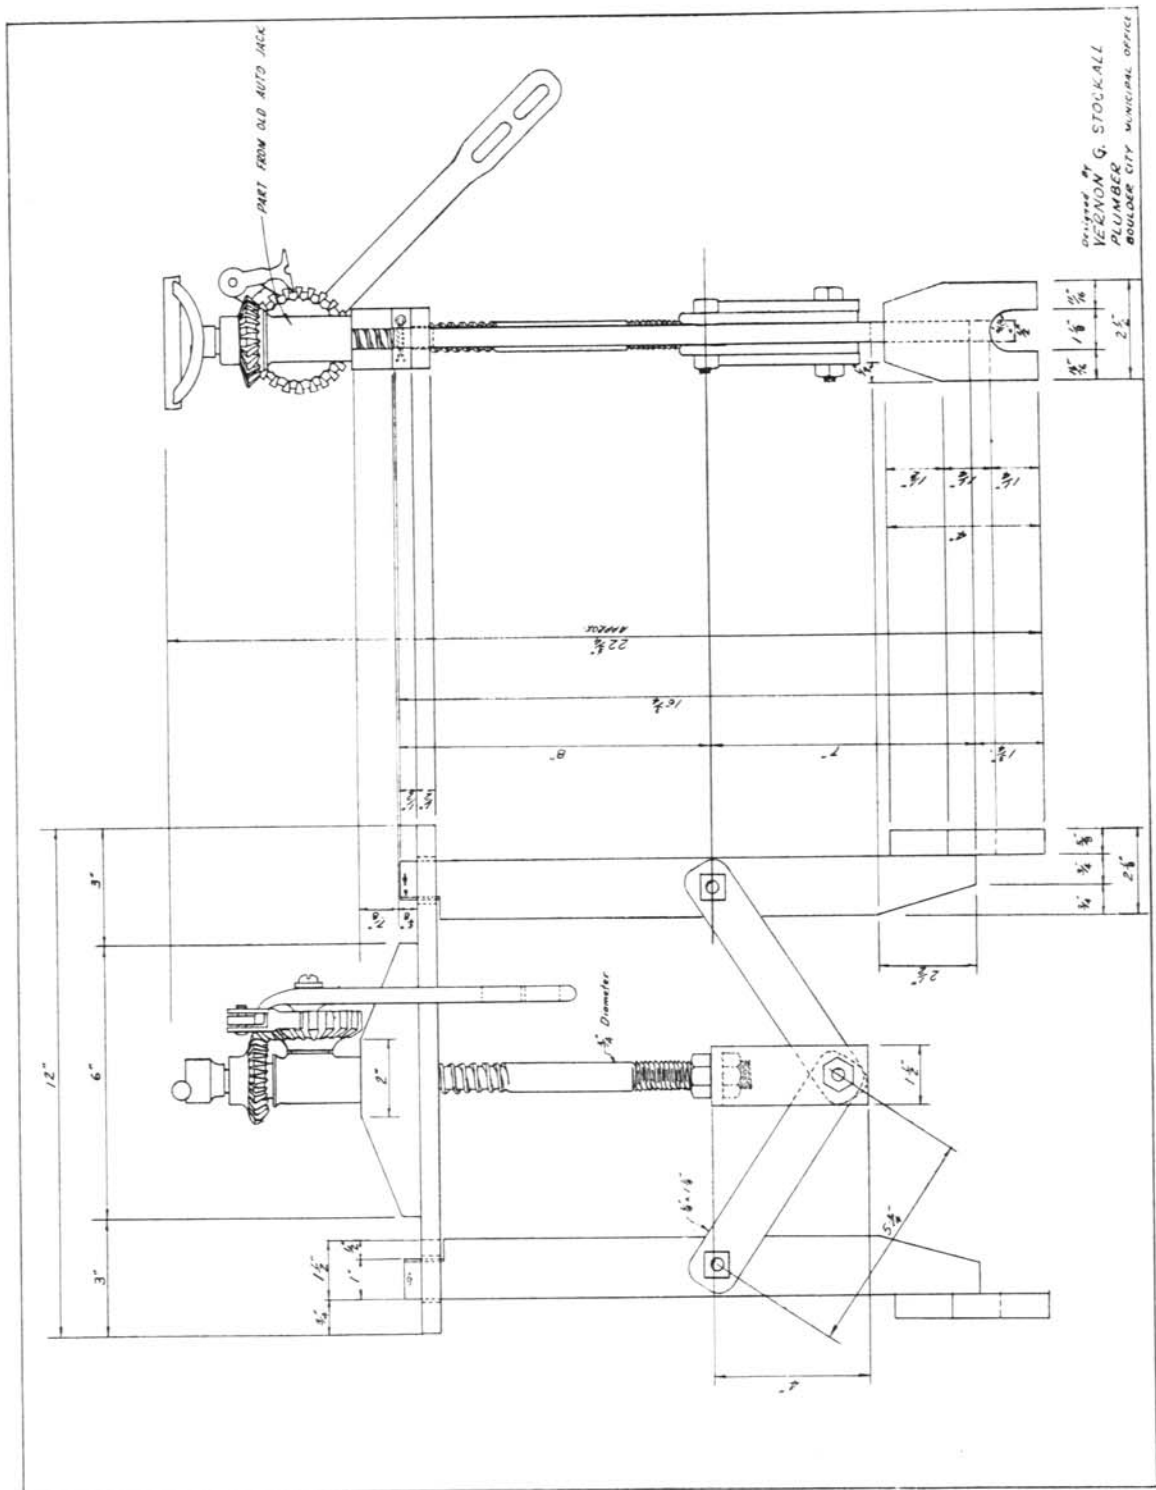
of effort in a very short time without damage to the pipeline, meter, or fittings. It is constructed from parts of an old automobile screw-jack and a few pieces of steel, with a minimum of machine work. The drawing on the following page gives the dimensions of the various steel parts.

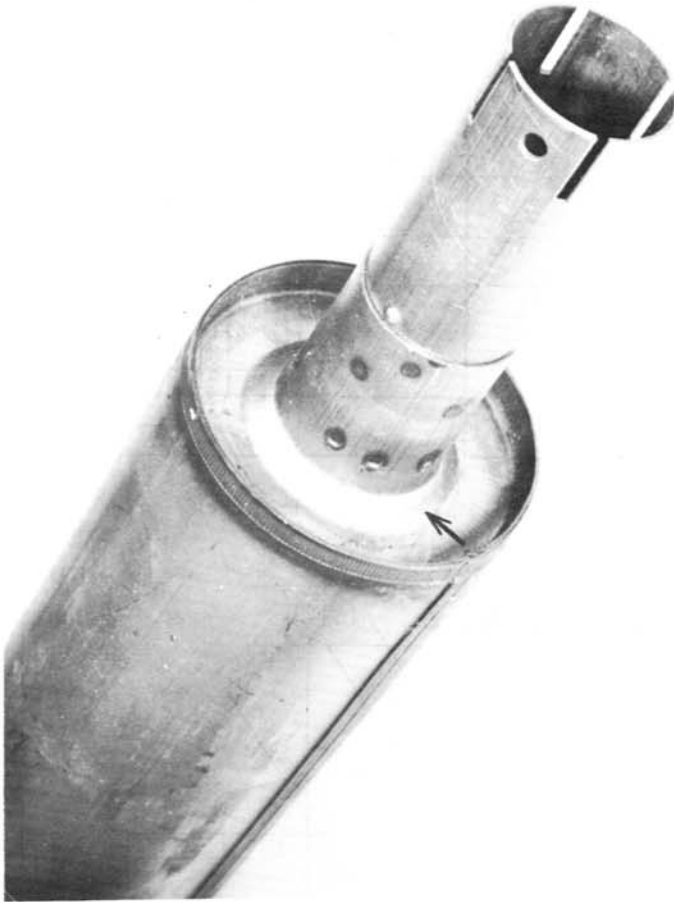
Some factory-furnished mufflers for vehicles are crimped to the inlet pipes. As there is often no hanger near this point on some vehicles, the muffler breaks down at the connection between the inlet pipe and the muffler with very little off-pavement use.

one shown, which eliminates the fault by having a formed neck for attachment to the inlet pipe, or one that has a welded connection provided.

Mr. Horace R. Howell, Mechanic Foreman on the project, suggests that mufflers furnished on new equipment and for replacement that are crimped to the inlet pipe, can be improved by welding a bead around the inlet pipe where it enters the muffler. The arrow on the photograph indicates the place at which the bead should be placed. Mr. Howell states the welding or brazing can be done by a mechanic

Experience on the Palisades Project, Idaho, with Willys vehicles, indicates that the vehicles equipped with mufflers of this type break down after about one week of construction or survey use, whereas a welded muffler lasts relatively indefinitely. The project recommends the purchase of replacement mufflers, similar to the
